COMPENDIUM OF POST-FAILURE ANALYSIS TECHNIQUES
FOR COMPOSITE MATERIALS

RAY GROVE, BRIAN SMITH
BOEING MILITARY AIRPLANE COMPANY
P. O. BOX 3707
M/S 73-43
SEATTLE, WASHINGTON 98124

JANUARY 1987

INTERIM REPORT FOR PERIOD JULY 1984 - NOVEMBER 1986

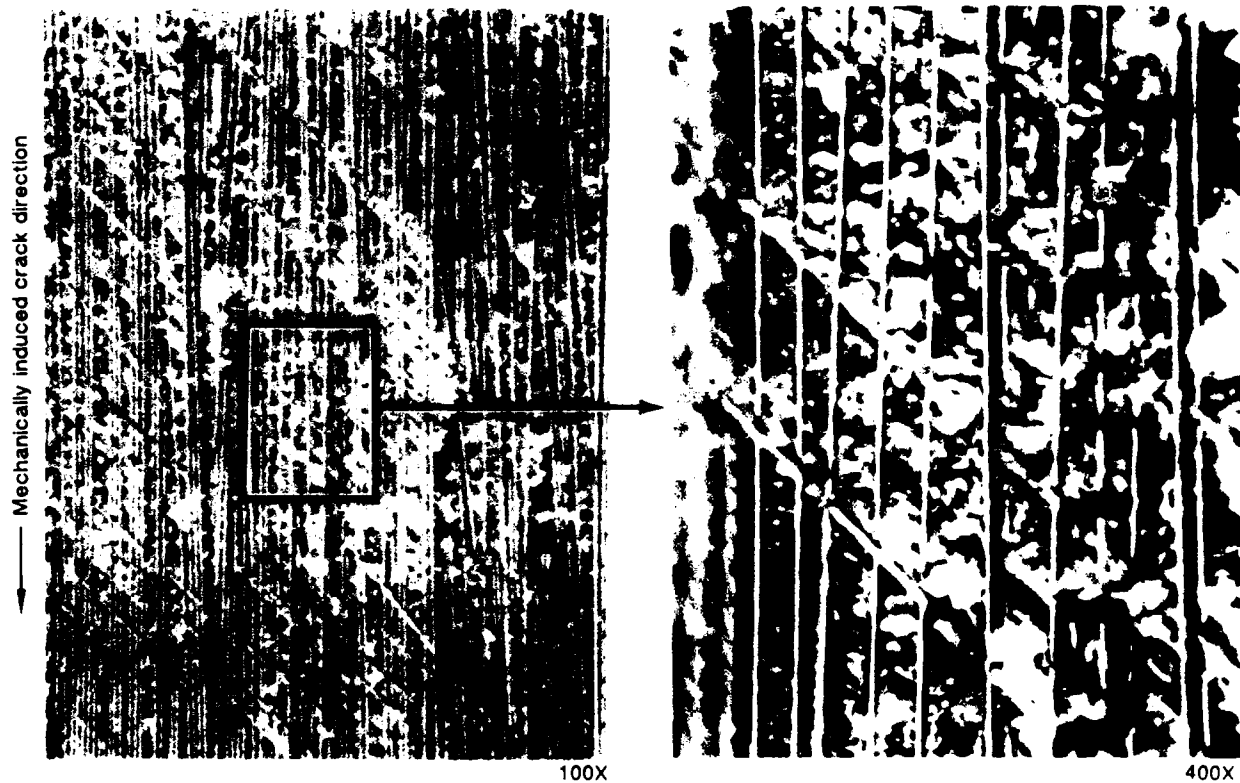
Fracture type	Interlaminar mode II shear
Ply layup	[0, 45] ₁₂ S
Test type	ENF
• Test conditions	21°C, dry
• Fracture between	0/45 plies
Material	Hercules 3501-6/177°C cure AS4 fibers

Figure 6-42. 0/45 Plies at 21°C Dry Condition (Optical 100X and 400X)

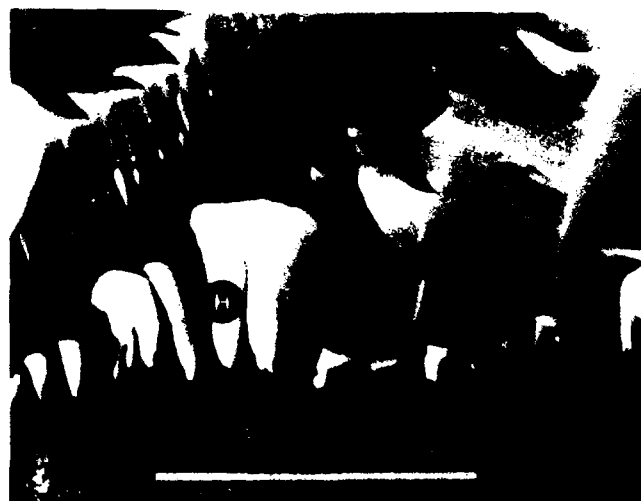
Fracture type	Interlaminar mode II shear
Ply layup	[0, 45] ₁₂ S
Test type	ENF
• Test conditions	RT
• Fracture between	0/45 plies
Material	Hercules 3501-6/177°C cure AS4 fibers

- F Fiber matrix separation
- H Hackles
- R River markings
- T Textured microflow

Figure 6-43. 0/45 Plies With Fiber Separation, River Marks, Hackles, and Textured Microflow

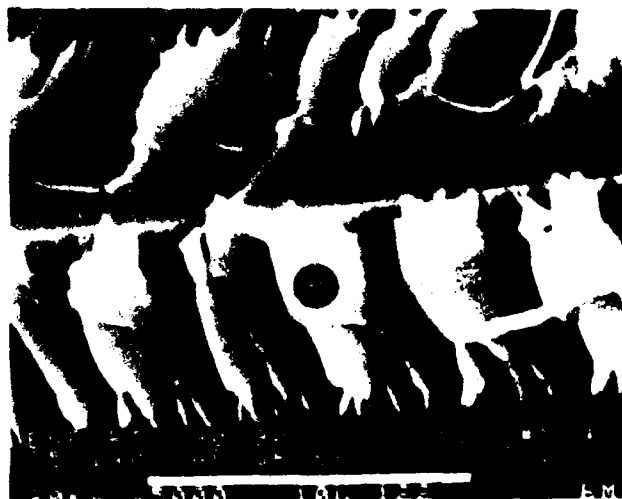
Fracture type	Interlaminar mode II shear
Ply layup	[90] 24
Test type	ENF
• Test conditions	21°C, dry
• Fracture between	90/90 plies
Material	Hercules 3501-6/177°C cure AS4 fibers

- F Fiber matrix separation
- H Hackles
- R River markings

Figure 6-46. 90/90 Plies at 21°C Dry Condition With Fiber Separation River Marks and Hackles

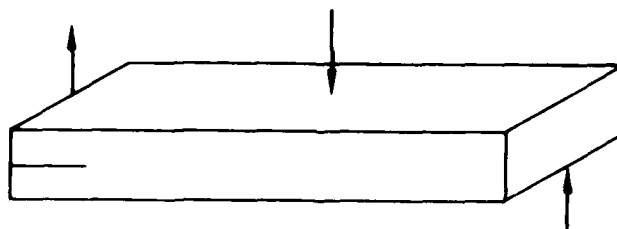
Figure 6-47 shows the test matrix for the Mixed Mode Flexural (MMF) test type.

The MMF test geometry produces 57 percent Mode I tension and 43 percent Mode II shear at the crack tip. The primary features observed are quite similar to those found in 100 percent Mode II shear fracture presented in the previous paragraph; the features are listed as follows:

Figure 6-47. Mixed Mode Flexural Test Type

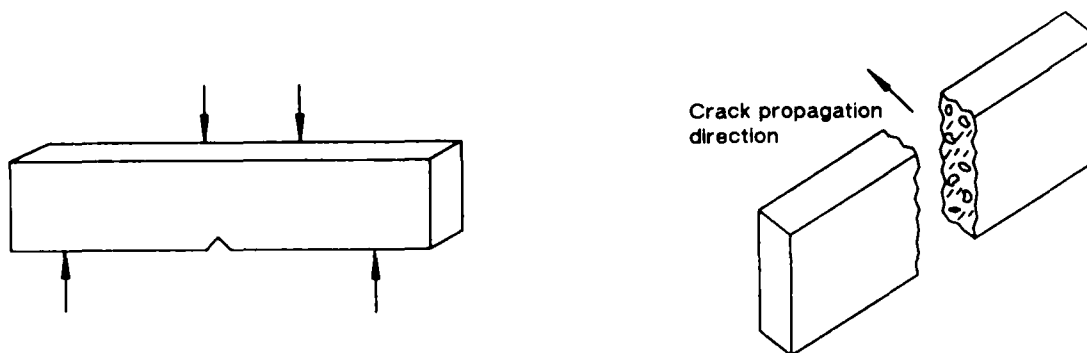
Figure 6-52 shows the test matrix for a tension four-point bend test type.

Figure 6-52. Four-Point Bend Test Type Tension

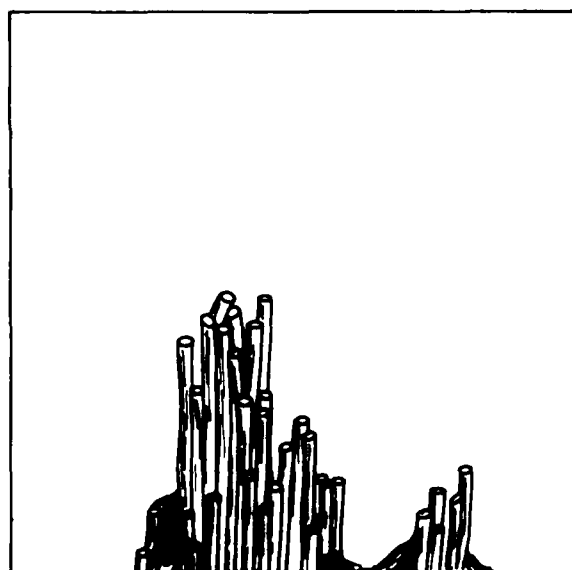
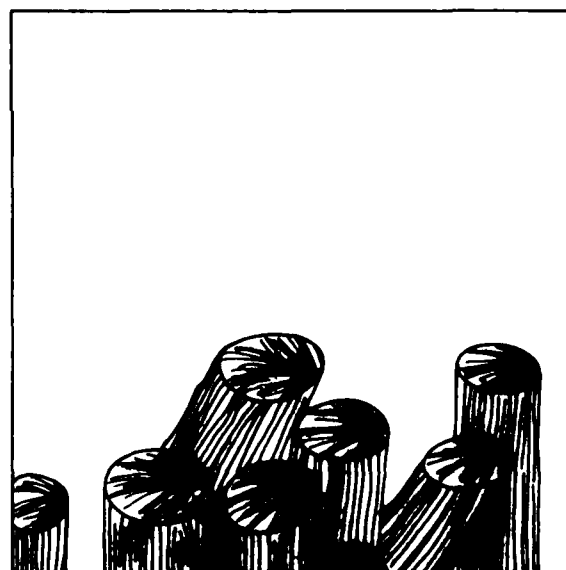
Low magnification

High magnification

←
Overall crack growth direction

Figure 6-53. Fracture of Adjacent Files

- Macroscopically rough fracture surface.
- Fibers protruding from the surface (fiber pullout) at a wide variety of heights.
- Radial feature on each fiber end.
- Fractured resin on sides of fibers, ranging from shear dominated hackle morphology to a very smooth nearly adhesive fracture.

During the fracture process an individual fiber will break, leading to fracture of adjacent fibers. This process continues at various planes throughout the laminate, resulting in a rough surface and groups of fibers or bundles. Close inspection of the fiber ends (using SEM) reveals a radiating pattern indicative of the fracture direction for each individual fiber. Inspection of the fiber ends at several locations along the fracture surface is required to determine the overall crack growth directions. For laminates with a wide variety of ply orientations, the fibers which are oriented 90 degrees to the fracture plane should be examined to obtain the best resulting reliability. When plies with fibers oriented parallel to the fracture plane are present, inspection of the intralaminar river marks may also be used to determine crack growth direction.

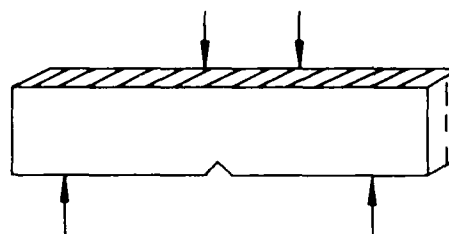
Fracture type	Translaminar mode I tension
Ply layup	[0, 90] 16S
Test type	Four-point bend
• Test conditions	Dry
• Fiber end fracture	
Material	Hercules 3501-6/177°C cure AS4 fibers

Figure 6-54. 0/90 Plies at -65°F Dry, 180°F Dry, and 270°F Dry Conditions (SEM Low Magnification)

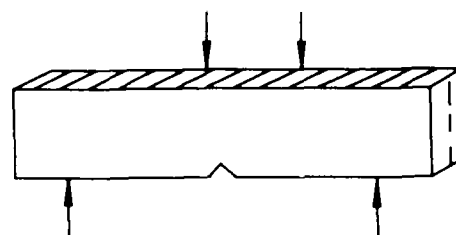
Fracture type	Translaminar mode I tension
Ply layup	[+45, -45] 16S
Test type	Four-point bend
• Test conditions	Wet
• Fiber end fracture	
Material	Hercules 3501-6/177°C cure AS4 fibers

Figure 6-55. +45/-45 Plies at 70°F Wet, 180°F Wet, and 270°F Wet Conditions (SEM 50X)

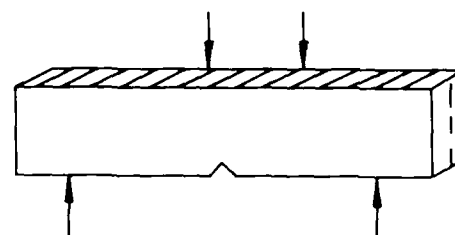
Fracture type	Translaminar mode I tension
Ply layup	[0, 90] _{16S}
Test type	Four-point bend
• Test conditions	82°C, dry
• Fiber end fracture	
Material	Hercules 3501-6/177°C cure AS4 fibers

Mechanically induced crack direction

Figure 6-56. 0/90 Plies at 82°C Dry Condition (Various SEM Magnification)

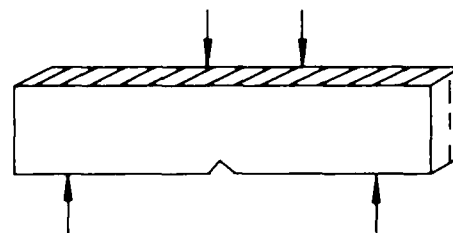
Fracture type	Translaminar mode I tension
Ply layup	[0, 90] 16S
Test type	Four-point bend
• Test conditions	Dry
• Fiber end fracture	
Material	Hercules 3501-6/177°C cure AS4 fibers

-65°F, dry

180°F, dry

270°F, dry

Figure 6-57 0/90 Plies at -65°F Dry, 180°F Dry, and 270°F Dry Conditions (SEM)

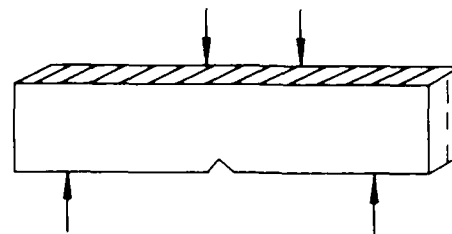
Fracture type	Translaminar mode I tension
Ply layup	[0, 90] _{16S}
Test type	Four-point bend
• Test conditions	Wet
• Fiber end fracture	
Material	Hercules 3501-6/177°C cure AS4 fibers

70°F, wet

180°F, wet

270°F, wet

Figure 6-58. 0/90 Plies at 70°F Wet, 180°F Wet, and 270°F Wet Conditions (SEM 50X)

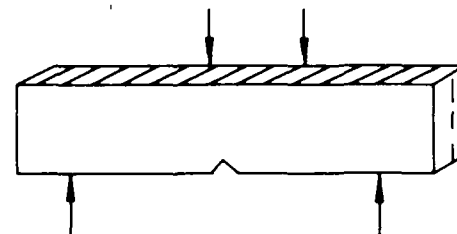
Fracture type	Translaminar mode I tension
Ply layup	[0, 90] ₁₆ S
Test type	Four-point bend
• Test conditions	Wet
• Fiber end fracture	
Material	Hercules 3501-6/177°C cure AS4 fibers

70°F, wet

180°F, wet

270°F, wet

Figure 6-59. 0/90 Plies at 70°F Wet, 180°F Wet, and 270°F Wet Conditions (SEM 2000X)

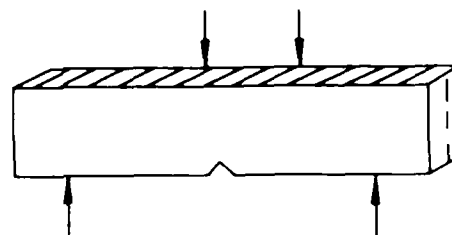
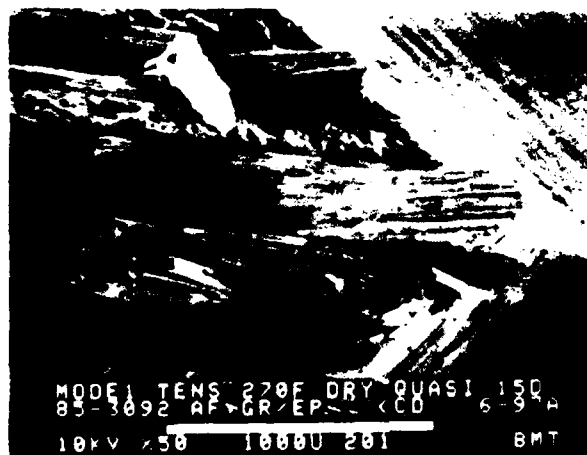
Fracture type	Translaminar mode I tension
Ply layup	[0, 45, 90] _{16S}
Test type	Four-point bend
• Test conditions	Dry
• Fiber end fracture	
Material	Hercules 3501-6/177°C cure AS4 fibers

-65°F, dry

180°F, dry

270°F, dry

Figure 6-60. 0/45/90 Plies at -65°F Dry, 180°F Dry, and 270°F Dry Conditions (SEM 50X)

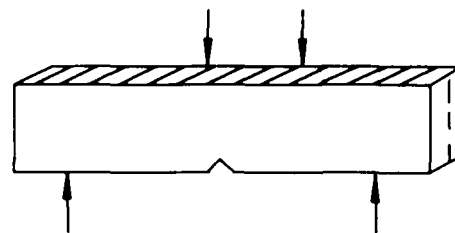
Fracture type	Translaminar mode I tension
Ply layup	[0, 45, 90] ₁₆ S
Test type	Four-point bend
• Test conditions	Dry
• Fiber and fracture	
Material	Hercules 3501-6/177°C cure AS4 fibers

-65°F, dry

180°F, dry

270°F, dry

Figure 6-61. 0/45/90 Plies at -65°F Dry, 180°F Dry, and 270°F Dry Conditions (SEM 2000X)

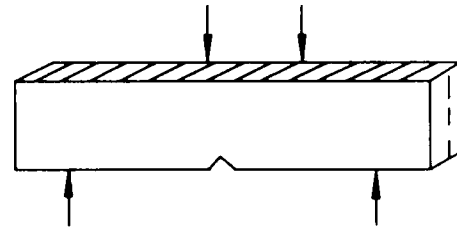
Fracture type	Translaminar mode I tension
Ply layup	[0, 45, 90] ₁₆ S
Test type	Four-point bend
• Test conditions	Wet
• Fiber end fracture	
Material	Hercules 3501-6/177°C cure AS4 fibers

70°F, wet

180°F, wet

270°F, wet

Figure 6-62. 0/45/90 Plies at 70°F Wet, 180°F Wet, and 270°F Wet Conditions (SEM 50X)

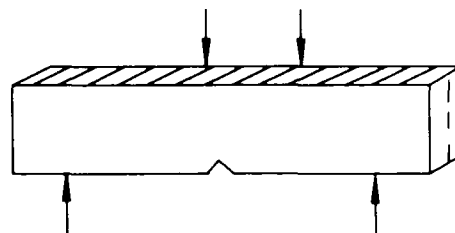
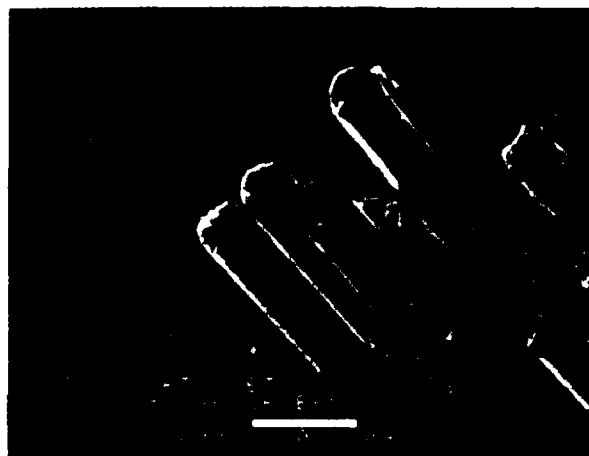
Fracture type	Translaminar mode I tension
Ply layup	[0, 45, 90] _{16S}
Test type	Four-point bend
• Test conditions	Wet
• Fiber end fracture	
Material	Hercules 3501-6/177°C cure AS4 fibers

70°F, wet

180°F, wet

270°F, wet

Figure 6-63. 0/45/90 Plies at 70°F Wet, 180°F Wet, and 270°F Wet Conditions (SEM 2000X)

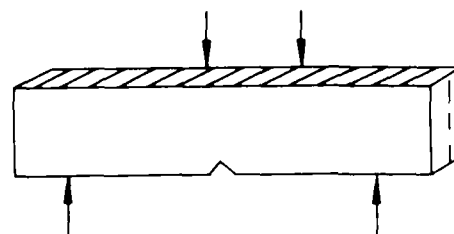
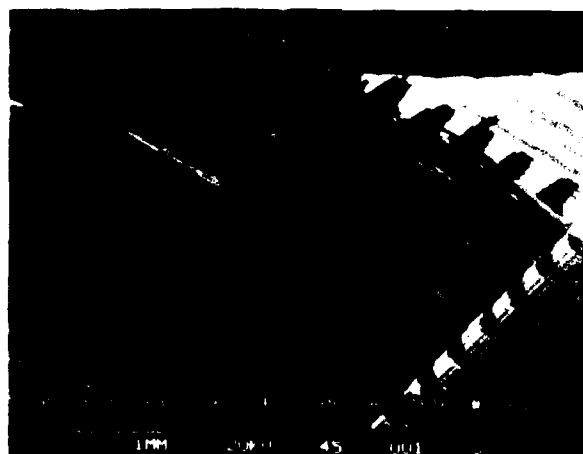
Fracture type	Translaminar mode I tension
Ply layup	[+45, -45] 16S
Test type	Four-point bend
• Test conditions	Dry
• Fiber end fracture	
Material	Hercules 3501-6/177°C cure AS4 fibers

-65°F, dry

180°F, dry

270°F, dry

Figure 6-64. +45/-45 Plies at -65°F Dry, 180°F Dry, and 270°F Dry Conditions (Fiber Pullout)

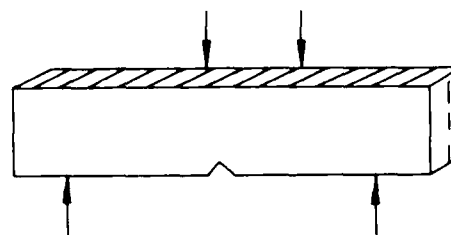
Fracture type	Translaminar mode I tension
Ply layup	[+45, -45] ₁₆ S
Test type	Four-point bend
• Test conditions	Dry
• Fiber end fracture	
Material	Hercules 3501-6/177°C cure AS4 fibers

-65°F, dry

180°F, dry

270°F, dry

Figure 6-65. +45/-45 Plies at -65°F Dry, 180°F Dry, and 270°F Dry Conditions (Fiber Breakage)

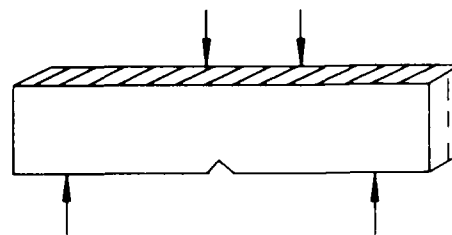
Fracture type	Translaminar mode I tension
Ply layup	[+45, -45] ₁₆ S
Test type	Four-point bend
• Test conditions	Wet
• Fiber end fracture	
Material	Hercules 3501-6/177°C cure AS4 fibers

Figure 6-66. +45/-45 Plies at 70°F Wet, 180°F Wet, and 270°F Wet Conditions (SEM 2000X)

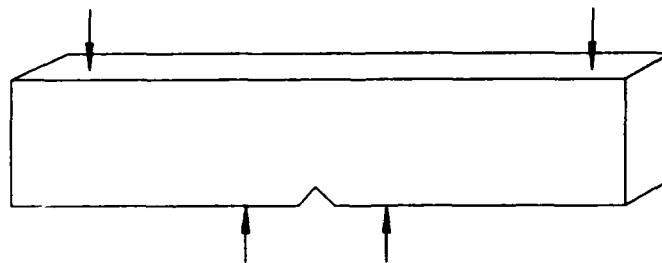
Figure 6-67. Four-Point Bend Test Type

Figure 6-67 shows the test matrix for compression four-point bend test type.

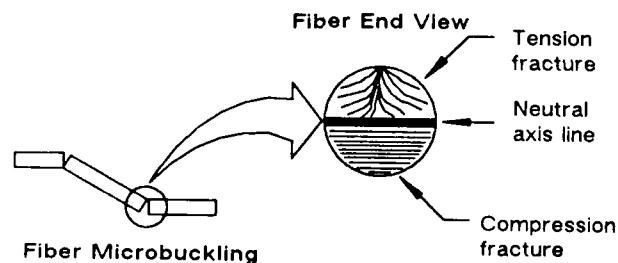
Figure 6-68. Translaminar Compression Fractures

Translaminar compression fractures occur by a combination of fiber microbuckling and delamination fractures. Examination of the fiber ends indicate a flexural fiber fracture.

Studies of these neutral axis lines have indicated that no direct correspondence to crack propagation is inferred. However, analysis of the delamination adjacent to the translaminar fracture may be used to identify crack growth direction if there is a predominance of Mode I tension during the fracture event.

Fractures produced at high temperatures and absorbed moisture content exhibit a rougher macroscopic fracture surface, with longer fiber chop and more secondary intralaminar shear cracks on the microscopic scale.

The reader should note that the low-magnification SEM photomicrographs reveal both compression fracture (flat) and tension fracture (fibers protruding). This is because the flexural nature of the test specimen, where cracking is initiated at the notch in compression. The high magnification photographs are from the compression fracture region.

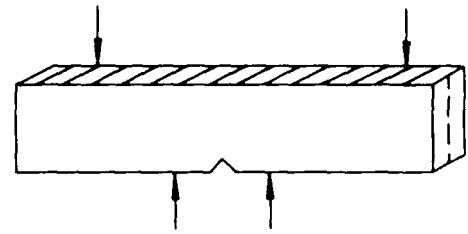
Fracture type	Translaminar mode I compression
Ply layup	[0] 32
Test type	Four-point bend
• Test conditions	21°C, dry
• Fiber end fracture	
Material	Hercules 3501-6/177°C cure AS4 fibers

Figure 6-69. 0 (32) Ply at 21°C Dry Condition (SEM 50X, 400X, and 2000X)

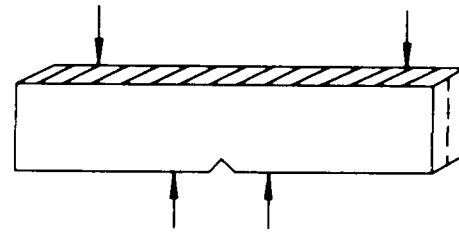
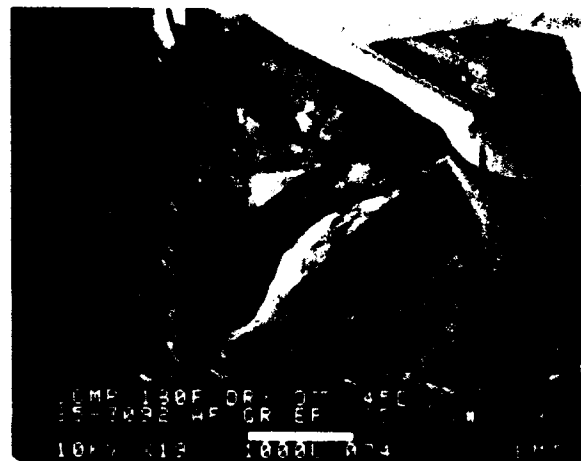
Fracture type	Translaminar mode I compression
Ply layup	[0] 32
Test type	Four-point bend
• Test conditions	Dry
• Fiber end fracture	
Material	Hercules 3501-6/177°C cure AS4 fibers

Figure 6-70. 0 (32) Ply at -65°F Dry, 180°F Dry, 270°F Dry Conditions (SEM Low Magnification)

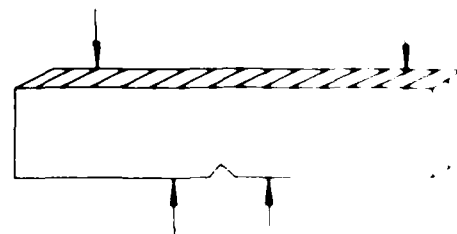
Fracture type	Translaminar mode I compression
Ply layup	[0] 32
Test type	Four-point bend
• Test conditions	Dry
• Fiber end fracture	
Material	Hercules 3501-6/177°C cure AS4 fibers

Figure 6-71. 0 (32) Ply at -65°F Dry, 180°F Dry, and 270°F Dry Conditions (SEM 400X)

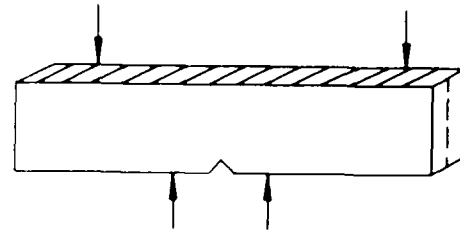
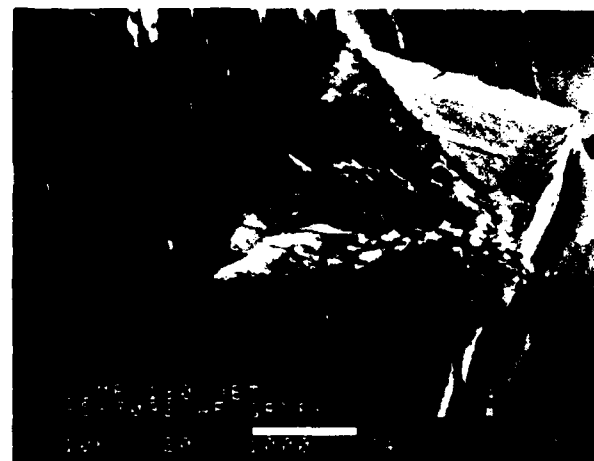
Fracture type	Translaminar mode I compression
Ply layup	[0] 32
Test type	Four-point bend
• Test conditions	Wet
• Fiber end fracture	
Material	Hercules 3501-6, 177°C cure AS4 fibers

Figure 6-72. 0 (32) Ply at 70°F Wet, 180°F Wet, and 270°F Wet Conditions (SEM 20X)

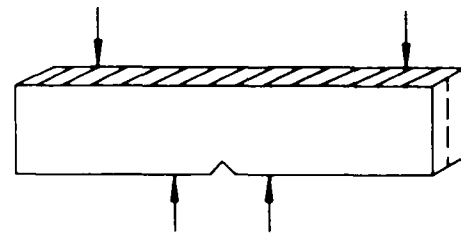
Fracture type	Translaminar mode I compression
Ply layup	[0]32
Test type	Four-point bend
• Test conditions	Dry
• Fiber end fracture	
Material	Hercules 3501-6/177°C cure AS4 fibers

Figure 6-73. [0]32 Ply at 70°F Wet, 180°F Wet, and 270°F Wet Conditions (SEM 400X)

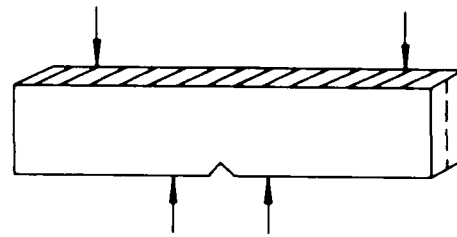
Fracture type	Translaminar mode I compression
Ply layup	[0, 90] 16S
Test type	Four-point bend
• Test conditions	21°C, dry
• Fiber end fracture	
Material	Hercules 3501-6/177°C cure AS4 fibers

Figure 6-74. 0/90 Plies at 21°C Dry Conditions (SEM 50X, 400X, and 2000X)

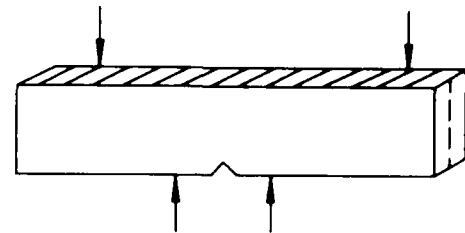
Fracture type	Translaminar mode I compression
Ply layup	[0, 90] ₁₆ S
Test type	Four-point bend
• Test conditions	Dry
• Fiber end fracture	
Material	Hercules 3501-6/177°C cure AS4 fibers

Figure 6-75. 0/90 Plies at -65°F Dry, 180°F Dry, and 270°F Dry Conditions (SEM 20X)

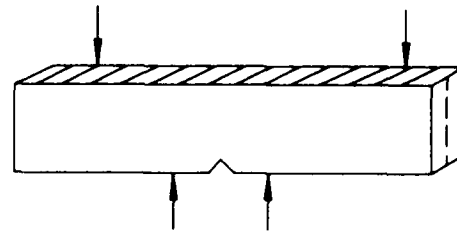
Fracture type	Translaminar mode I compression
Ply layup	[0, 90] ₁₆ S
Test type	Four-point bend
• Test conditions	Dry
• Fiber end fracture	
Material	Hercules 3501-6/177°C cure AS4 fibers

Figure 6-76. 0/90 Plies at -65°F Dry, 180°F Dry, and 270°F Dry Conditions (SEM 400X)

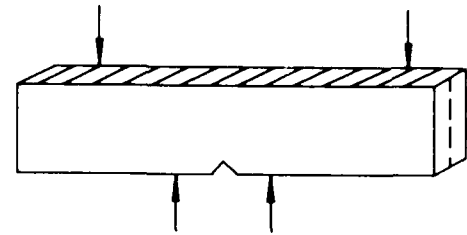
Fracture type	Translaminar mode I compression
Ply layup	[0, 90] ₁₆ S
Test type	Four-point bend
• Test conditions	Wet
• Fiber end fracture	
Material	Hercules 3501-6/177°C cure AS4 fibers

Figure 6-77. 0/90 Plies at 70°F Wet, 180°F Wet, and 270°F Wet Conditions (SEM 20x)

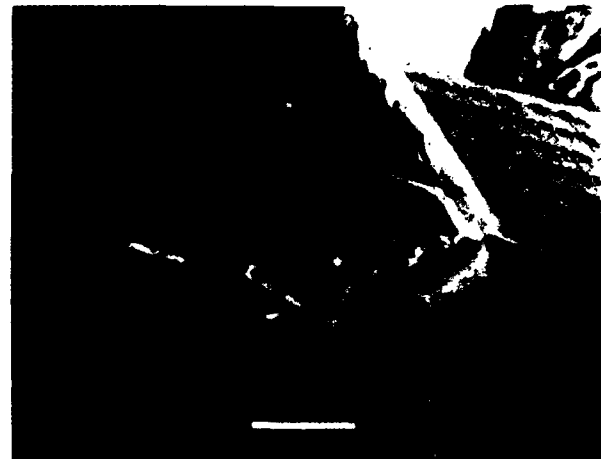
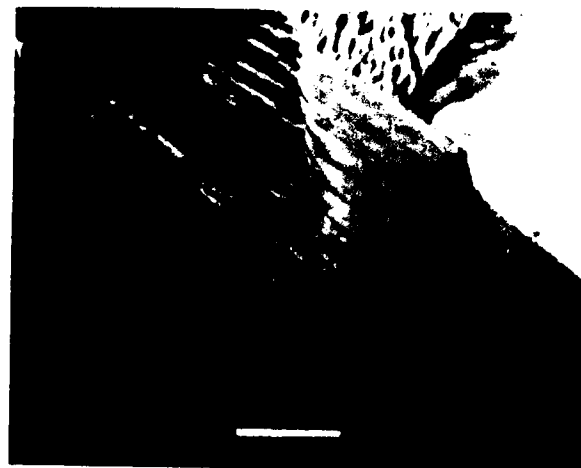
Fracture type	Translaminar mode I compression
Ply layup	[0, 90] ₁₆ S
Test type	Four-point bend
• Test conditions	Wet
• Fiber end fracture	
Material	Hercules 3501-6/177°C cure AS4 fibers

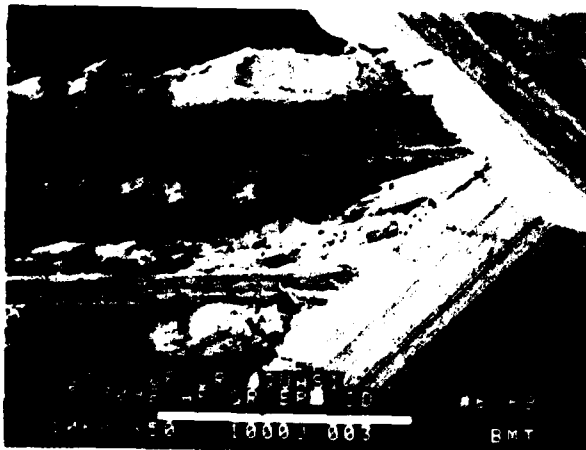
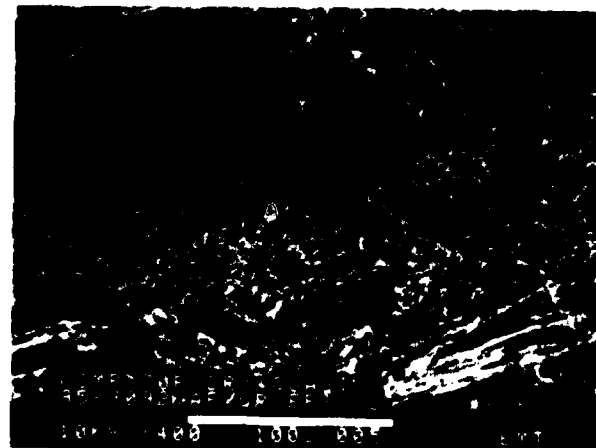
Figure 6-79. 0/45/90 Plies at 21°C Condition (SEM 50X, 400X, and 2000X)

Fracture type	Translaminar mode I compression
Ply layup	[0, 45, 90] _{16S}
Test type	Four-point bend
• Test conditions	Dry
• Fiber end fracture	
Material	Hercules 3501-6/177°C cure AS4 fibers

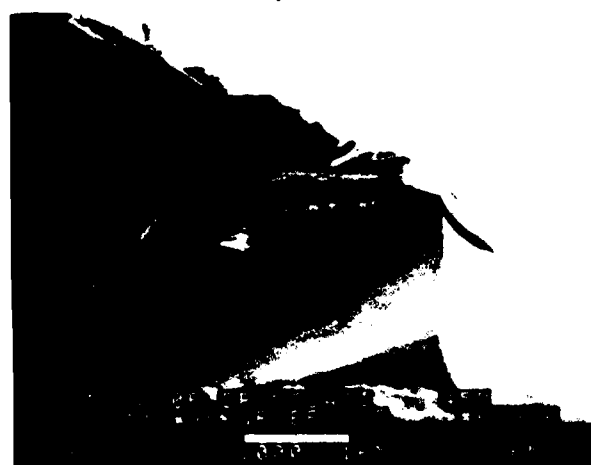
Figure 6-80. 0/45/90 Plies at -65°F Dry, 180°F Dry, and 270°F Dry Conditions (SEM 20X)

Fracture type	Translaminar mode I compression
Ply layup	[0, 45, 90] 16S
Test type	Four-point bend
• Test conditions	Wet
• Fiber end fracture	
Material	Hercules 3501-6/177°C cure AS4 fibers

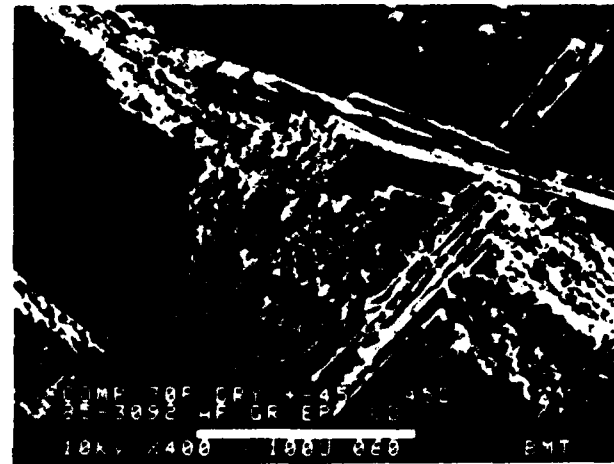
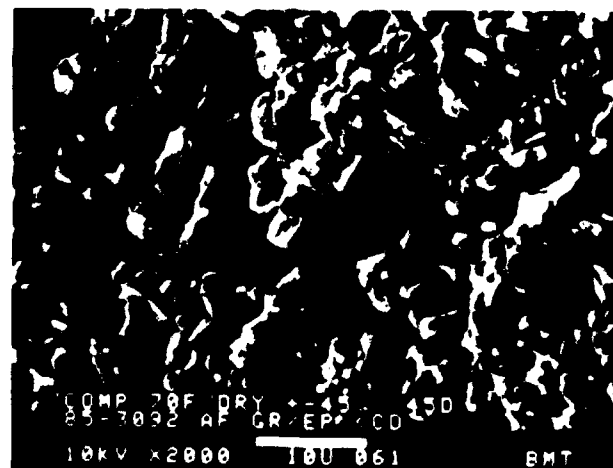
Figure 6-83 +45/-45 Plies at 21°C Dry Condition (SEM 50X, 400X, and 2000X)

Fracture type	Translaminar mode I compression
Ply layup	[+45, -45]16S
Test type	Four-point bend
• Test conditions	Dry
• Fiber end fracture	
Material	Hercules 3501-6/177°C cure AS4 fibers

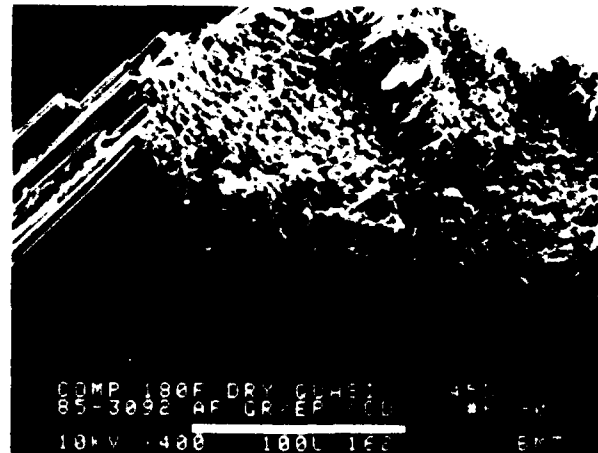
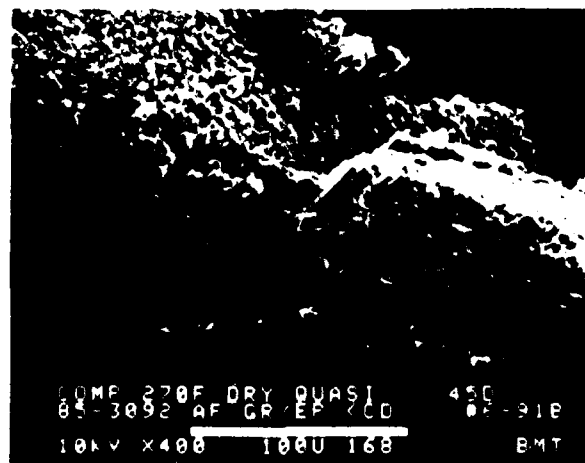
Figure 6-85. 0/45/90 Plies at -65°F Dry, 180°F Dry, and 270°F Dry Conditions (SEM 400X)

Fracture type	Translaminar mode I compression
Ply layup	[+45, -45] 16S
Test type	Four-point bend
• Test conditions	Dry
• Fiber end fracture	
Material	Hercules 3501-6/177°C cure AS4 fibers

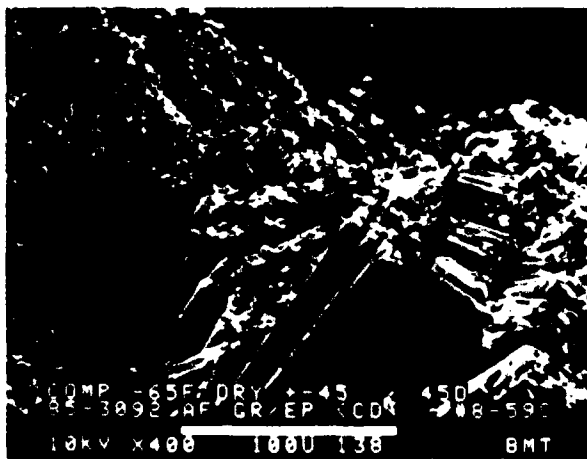
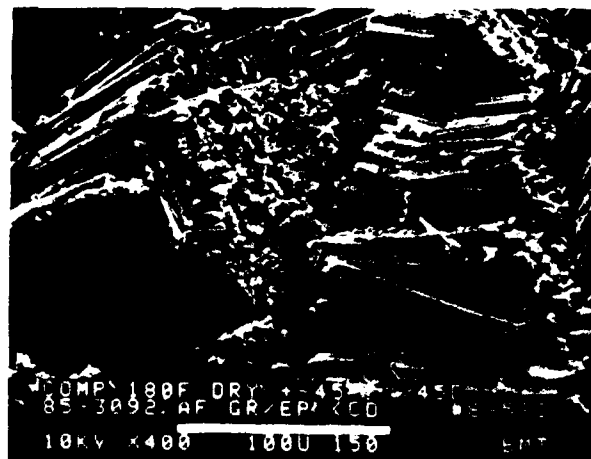
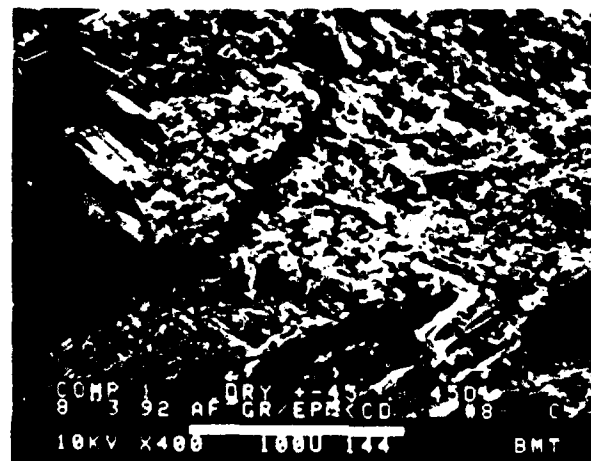
Figure 6-86. +45/-45 Plies at -65°F Dry, 180°F Dry, and 270°F Dry Conditions (SEM 400X)

Fracture type	Translaminar mode I compression
Ply layup	[+45, -45] 16S
Test type	Four-point bend
• Test conditions	Wet
• Fiber end fracture	
Material	Hercules 3501-6/177°C cure AS4 fibers

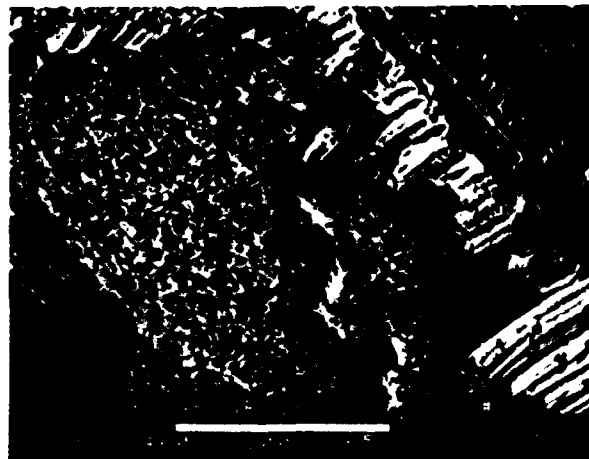
Figure 6-88. +45/-45 Plies at 70°F Wet, 180°F Wet, and 270°F Wet Conditions (SEM 400X)

Fracture type	Translaminar mode I compression
Ply layup	[+45, -45] 16S
Test type	Four-point bend
• Test conditions	Dry
• Fiber end fracture	
Material	Hercules 3501-6/177°C cure AS4 fibers

Mechanically induced crack direction

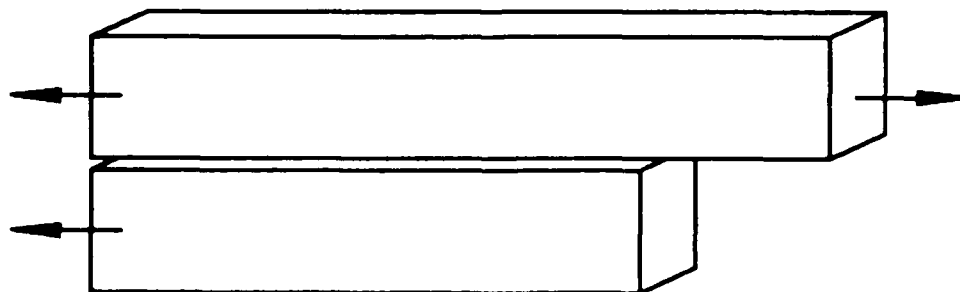
Figure 6-89. Side-Notched Rail Shear Test Type

Figure 6-89 shows the test matrix for a side-notched rail shear test type.

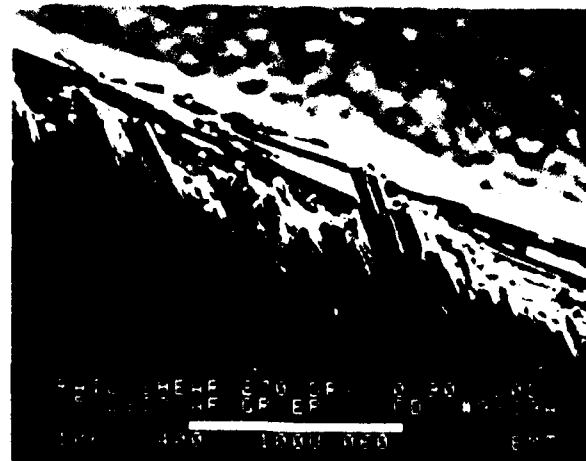
Figure 6-91. 0/90 Plies at -65°F Dry, 180°F Dry, and 270°F Dry Conditions (SEM 400X)

Fracture type	Translaminar mode II shear
Ply layup	[0, 90] _{16S}
Test type	Side-notched rail shear
• Test conditions	Dry
• Fiber end fracture	
Material	Hercules 3501-6/177°C cure AS4 fibers

See Figures 6-90 through 6-99.

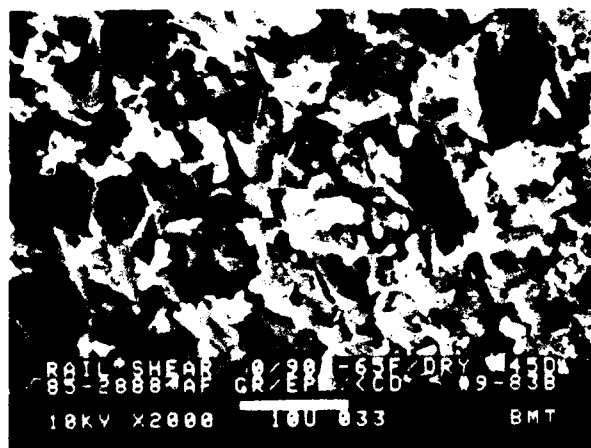
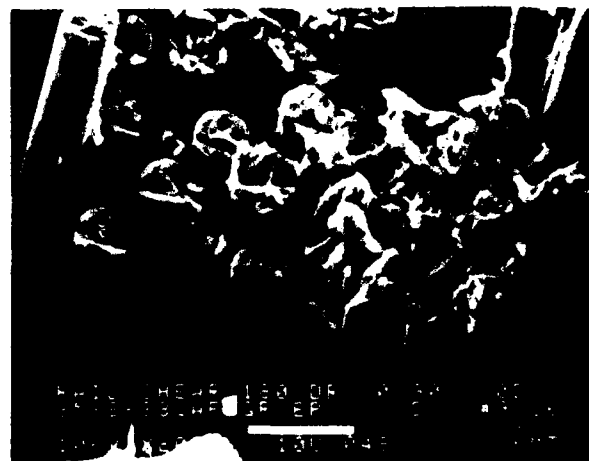
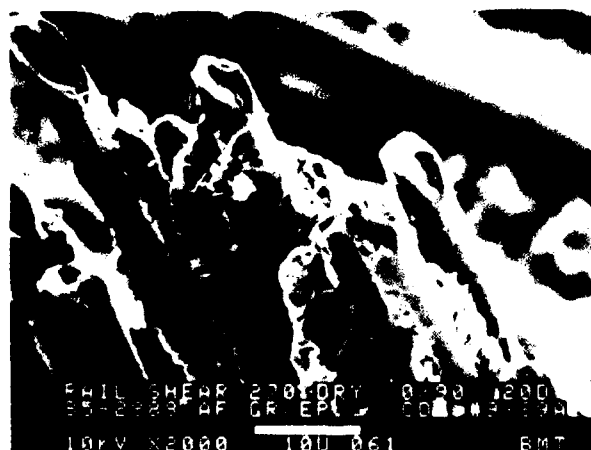
Figure 6-92. 0/90 Plies at -65°F Dry, 180°F Dry, and 270°F Dry Conditions (SEM 2000X)

Fracture type	Translaminar mode II shear
Ply layup	[0, 90] _{16S}
Test type	Side-notched rail shear
• Test conditions	Dry
• Fiber end fracture	
Material	Hercules 3501-6/177°C cure AS4 fibers

Mechanically Induced crack direction

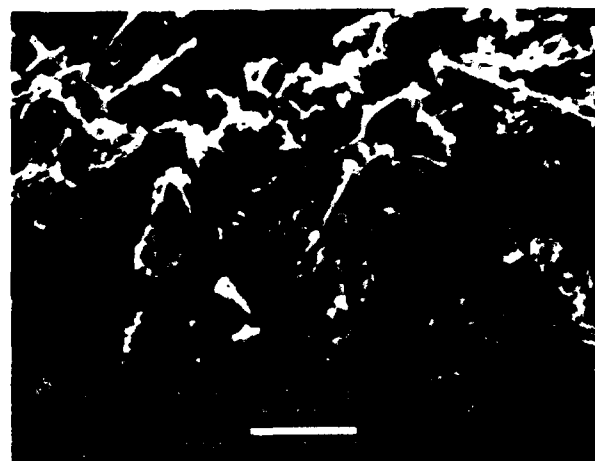
Figure 6-94. 0/90 Plies at 70°F Wet, 180°F Wet, and 270°F Wet Conditions (SEM 2000X)

Fracture type	Translaminar mode II shear
Ply layup	[0, 90] _{16S}
Test type	Side-notched rail shear
• Test conditions	Wet
• Fiber end fracture	
Material	Hercules 3501-6/177°C cure AS4 fibers

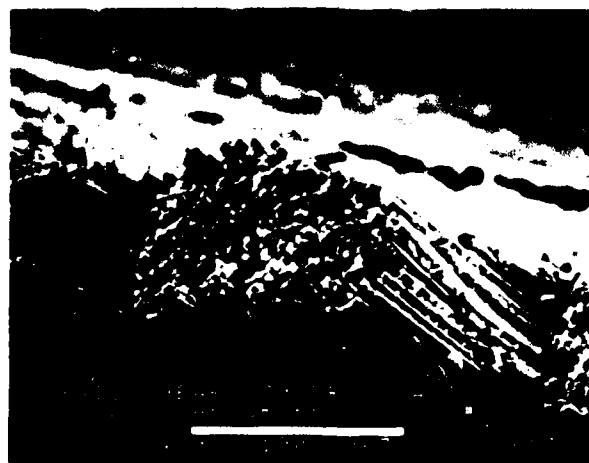
Figure 6-96. 0/45/90 Plies at -65°F Dry, 180°F Dry, and 270°F Dry Conditions (SEM 400X)

Fracture type	Translaminar mode II shear
Ply layup	[0.45, 90] _{16S}
Test type	Side-notched rail shear
• Test conditions	Dry
• Fiber end fracture	
Material	Hercules 3501-6/177°C cure AS4 fibers

Mechanically induced crack direction

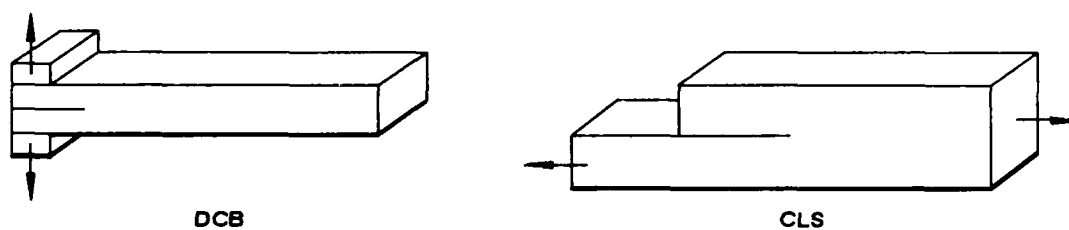
Figure 6-102. Double Cantilever Beam (DCB) for Mode I Fractures Crack Lap Shear (CLS) for Mode II Fractures

Figure 6-102 shows the text matrix of Double Cantilever Beam (DCB) for Mode I fractures and Crack Lap Shear (CLS) for Mode II fractures.

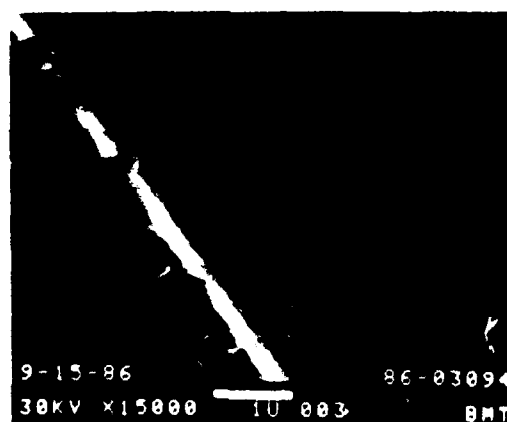
Figure 6-108. 0/0 Plies at 21°C Dry Condition (Fatigue CLS Mode II, 40% to 80% Static)

Fracture type	Interlaminar fatigue mode II shear
Ply layup	[0] 24
Test type	Fatigue CLS (80% to 40% G _{II} C)
• Test conditions	21°C, dry
• Fracture between	0/0 plies
Material	Hercules 3501-6/177°C cure AS4 fibers

Mechanically induced crack direction

See Figures 6-103 through 6-109.

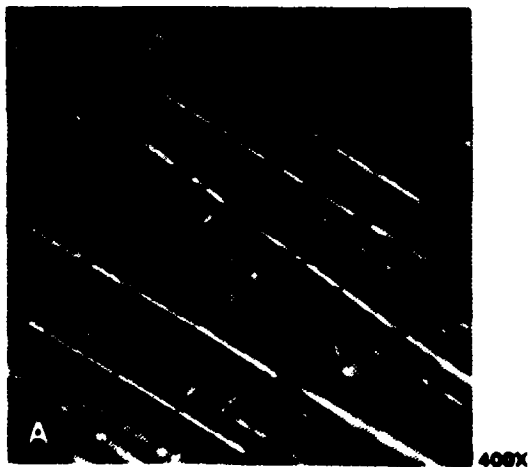
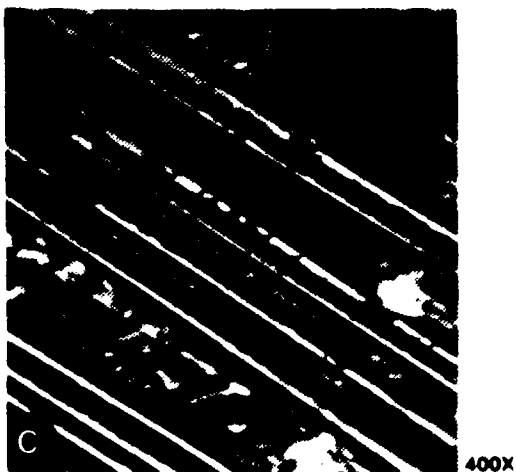
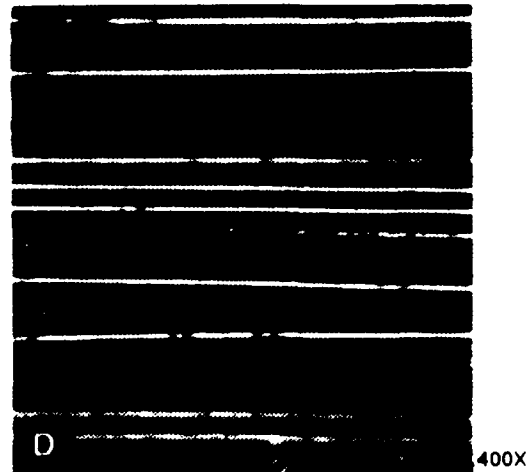
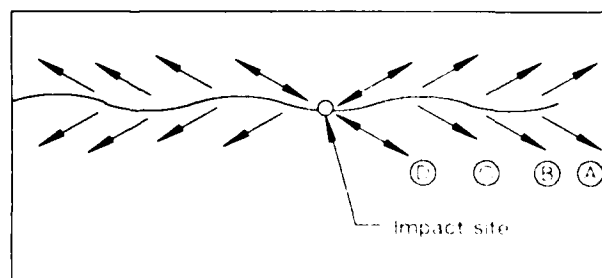
Figure 6-113. 0/45/90 Plies, Dry Conditions (Compression After Impact)

Figure 6-113 shows an example of a Compression After Impact (CAI) test type. The test consisted of:

- Compression buckling of the laminate through the impact site (with extensive delamination).
- Shear dominated interlaminar fracture features at the impact region (origin).
- Tension dominated interlaminar fracture features at the specimen outer edges.
- Crack mapping of the river marks and resin microflow to identify crack growth direction (and thus the origin).

Fracture type	Interlaminar/translaminar
Ply layup	[0, 45, 90] 8S
Test type	Compression after impact
• Test conditions	Dry
• Fracture between	0/45/90 plie.
Material	Hercules 3501-6/177°C cure AS4 fibers

Key to crack growth
direction arrows
— Mode I tension
— Mode II shear

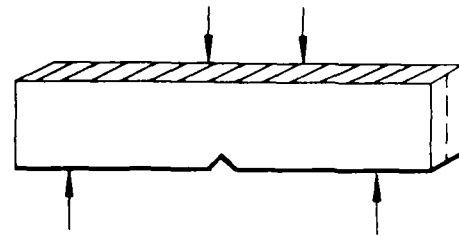
Figure 6-117. Fiberglass/Epoxy 250°F Cure

Fracture type	Translaminar mode I tension
Ply layup	[0, 90] _{4S} tape
Test type	Four-point bend
• Test conditions	21°C, dry
• Fracture between	0/90 plies
Material	Fiberglass-epoxy 250°F cure

Mechanically induced crack direction

121°C (250°F) Cure Fiberglass/Epoxy (see Figure 6-117)

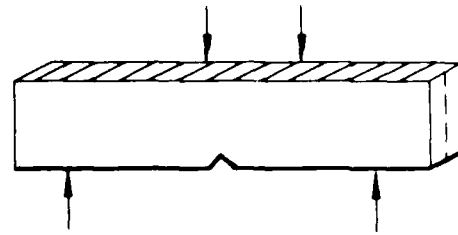
Figure 6-118 Fiberglass Epoxy, 350°F Cure

Fracture type	Translaminar mode I tension
Ply layup	[0, 90] _{4S} tape
Test type	Four-point bend
• Test conditions	21°C, dry
• Fracture between	0/90 plies
Material	Fiberglass-epoxy 350°F cure

Mechanically induced crack direction

177°C (350°F) Cure Fiberglass/Epoxy (see Figure 6-118)
